REPORT NO. 04-19-2

TRANSPORTABILITY TESTING OF THE INTERMODAL STORAGE AND TRANSPORT FRAMES (ISTF-2s), TP-94-01, "TRANSPORTABILITY TESTING PROCEDURES"

Transportability Testing of the Intermodal Storage and Transport Frames (ISTF-2), TP-94-01, Revision 2, June 2004 "Transportability Testing Procedures"

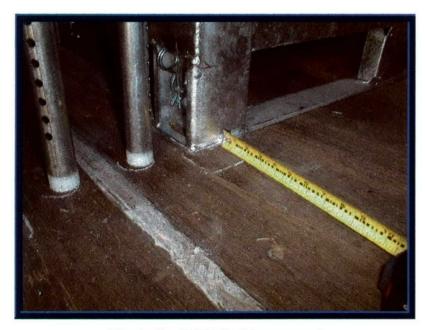
- 1. Figure 5 lists the average speeds of the specimen car immediately prior to impact with the anvil. Impacts #5 and #6 are the reverse impacts.
- 2. Impacts #1 and #5 were each determined to be a "no test" due to the insufficient velocity at impact. The tests were repeated.
- 3. Following Impact #2 a cap from the Rapid ISO Bracing System (RIBS) locking pin finger holds came off.
- 4. Following Impact #3 the ISTF-2s moved 0.125 inches in the direction of impact.
- 5. Following Impact #4 the ISTF-2s moved an additional 0.125-0.375 inches in the direction of impact. The vertical stay of the RIBS cradle moved 0.5 inches and the RIBS beams bowed.
- 6. Following Impact #5 the ISTF-2s moved 1.75-2.5 inches in the direction of impact.

Photo 3. ISTF-2s Movement

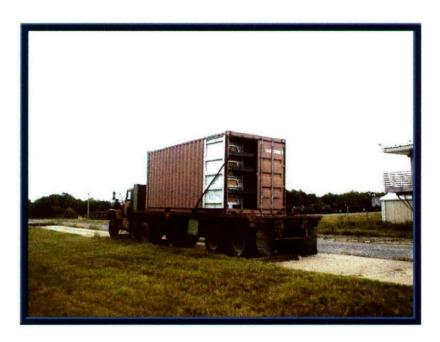
Photo 4. Hazard Course Testing of the ISTF-2s in an End-Opening Intermodal Container

- 1. Figure 6 lists the average speeds of the test load through the Hazard Course.
- 2. Inspection following Pass #1 revealed that the ISTF-2s had moved toward the container door 0.5 inches (toward the rear of the trailer).

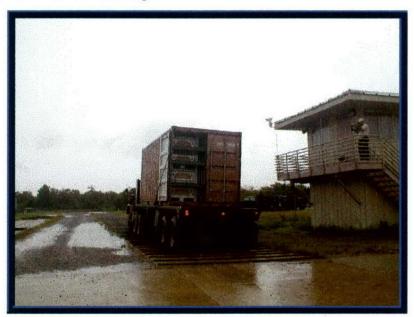
Photo 5. Washboard Course Testing of the ISTF-2s in an End-Opening Container

<u>Remark</u>: Inspection following the completion of the Washboard Course revealed no additional movement or damage.

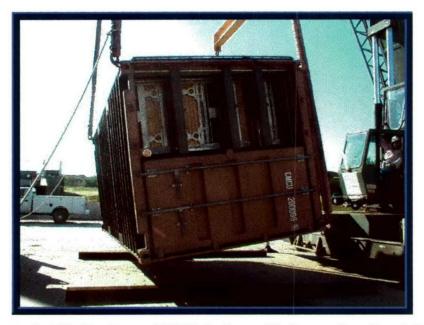
Photo 6. Tilt Testing of ISTF-2s in an End-opening Container

<u>Remark</u>: Inspection following the completion of the tilt testing revealed no additional movement or damage.

D. <u>CONCLUSION</u>: As tested the ISTF-2s successfully completed transportability testing in an end-opening intermodal container. Installation of the cradles of the RIBS was difficult due to the limited space and tolerances between the rows of the ISTF-2s. The cradles could not be installed efficiently and safely. The cradles had to be shoved and banged into position using a forklift. After completion of the testing the cradles had to be pulled out of position using a chain and forklift. Damage did occur to the cradles when they were removed. Therefore, blocking and bracing of the ISTF-2s, using the RIBS cradles, is not acceptable.

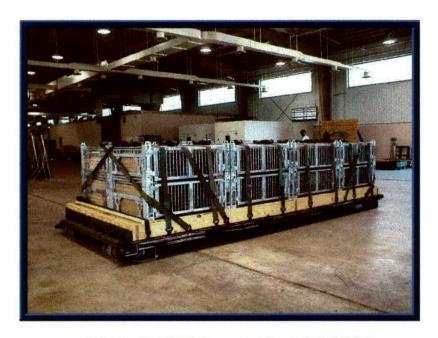
Photo 7. ISTF-2s on a Hyundai CROP

The test sketch shows the forward blocking assembly by the CROP A-frame. During the load build, the strap going over the assembly could not be achieved at that position. Therefore, the assembly was switched to the rear of the load as shown in Photo 7. The corner strapping board assembly, as shown in the test sketch (See Part 6), was not necessary for this load.

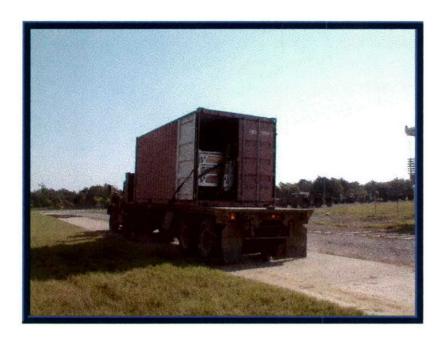
Photo 9. Hazard Course Testing of the ISTF-2s on a Hyundai CROP

- 1. Figure 10 lists the average speeds of the test load through the Hazard Course.
- 2. Inspections following each pass revealed no additional movement or damage.

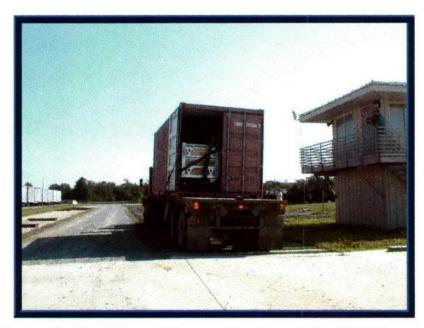
Photo 10. Washboard Course Testing of the ISTF-2s on a Hyundai CROP

Remark: Inspection following the completion of the Washboard Course testing revealed no additional movement or damage.

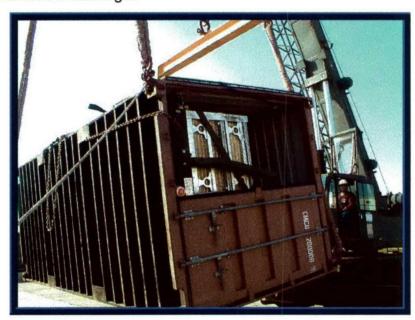
Photo 11. Tilt Testing of ISTF-2s on a Hyundai CROP

Remark: Inspection following the completion of the tilt testing revealed no additional movement or damage.

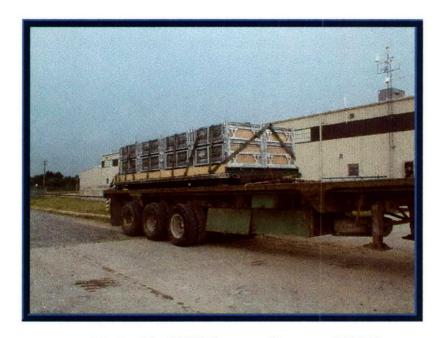
Photo 12. ISTF-2s on a Summa CROP

Notes: The testing was conducted as evaluation testing of the interlocks on the ISTF-2s. The testing was not conducted to verify the interlocks for ammunition transport. The tiedowns were located at the 2, 3, 4, 7, 13, 15, and 17 anchor locations on the CROP. The corner strapping assemblies, as shown in the test sketch (See Part 6), were not necessary for this load. No aft filler was required for this load. The ISTF-2s were held in place using eight 3-inch-wide CROP straps. The ISTF-2s were interlocked.

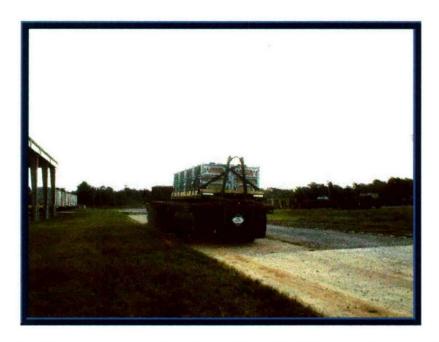
Photo 13. Hazard Course Testing of the ISTF-2s on a Summa CROP

- 1. Figure 12 lists the average speeds of the test load through the Hazard Course.
- 2. Inspections following each pass revealed no movement or damage.

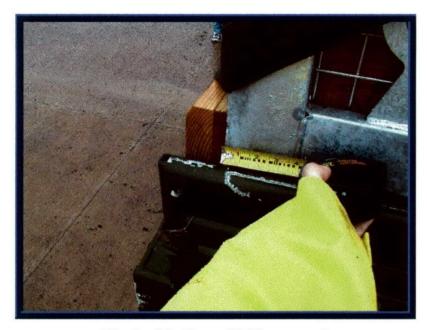
- 1. Figure 13 lists the average speeds of the test load through the Hazard Course.
- 2. Inspections following Pass #3 revealed that the ISTF-2s had moved 0.5 inches toward the passenger side.

Photo 14. Pass #3 Movement

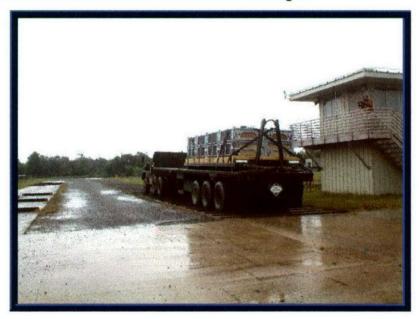
Photo 15. Washboard Course Testing of the ISTF-2s on a Summa CROP

Remark: Inspection following the completion of the Washboard Course testing revealed no additional movement or damage.
